NEW YORK STATE DEPT OF ENVIRONMENTAL CONSERVATION ALBANY F/G 13/2  
NATIONAL DAM SAFETY PROGRAM. DIAMOND MILLS PAPER COMPANY DAM (N--ETC(U)  
AUG 78 E A NOWATZKI, G S SALZMAN DACW51-78-C-0035

ENGINEERS FROM THE CONSULTING FIRM OF WARD-ZETLIN, UNDER CONTRACT TO THE STATE OF NEW YORK, DEPARTMENT OF ENVIRONMENTAL CONSERVATION INSPECTED THE DIAMOND MILL PAPER COMPANY DAM, ULSTER COUNTY, NEW YORK (I.D. NO. 89) ON 29 JUNE 1978 AS PART OF THE NATIONAL DAM INSPECTION PROGRAM.

OVERVIEW - DIAMOND MILLS PAPER COMPANY DAM

**APPENDIX D**  
**PHOTOGRAPHS**

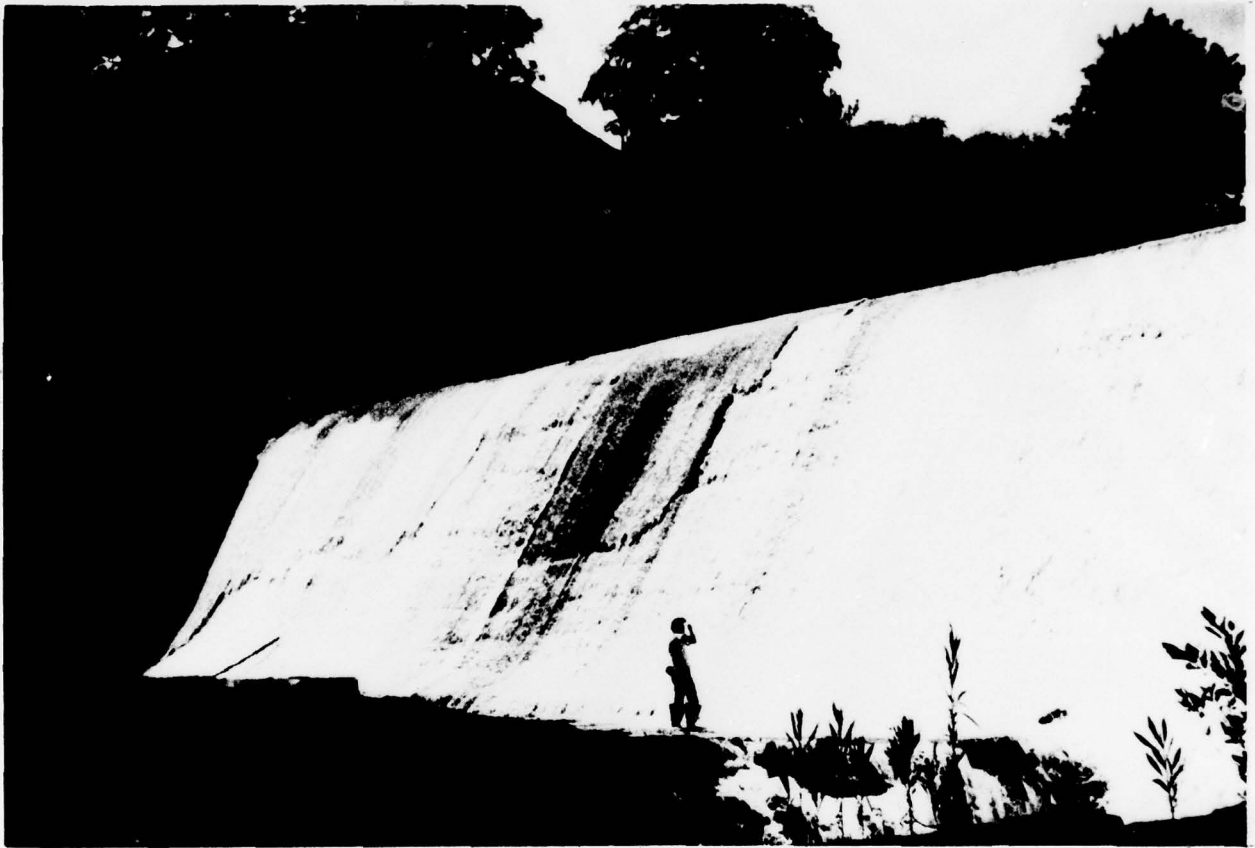
apparent that the concrete face of the dam is badly cracked, scaled and spalled (Fig. 3, Appendix D; also Overview picture). Construction joints between the monoliths appear to be open to a significant depth (Fig. 4, Appendix D) and spalling on the joints at some sections along the crest has left what appear to be V-notches (Figs. 5 and 6, Appendix D). The monoliths at some sections appear to be offset horizontally 6± inches; however, it is difficult to tell whether there is actually an offset or whether there appears to be an offset because of the large amount of spalling that has taken place (Figs. 6 and 7, Appendix D). At some sections along the spillway crest it is apparent that a large amount of spalling has taken place (Fig. 24, Appendix D).

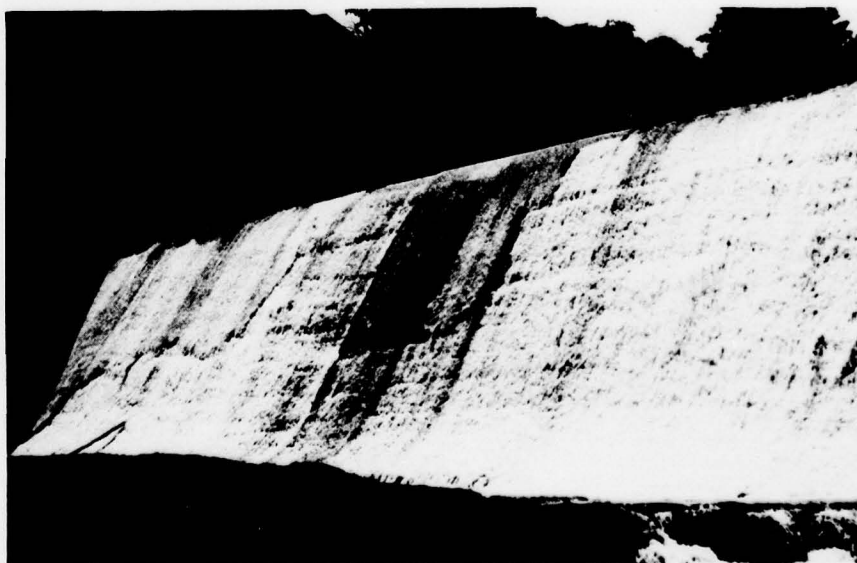
spalls (see, for example, Figs. 3, 4, 5, 9 and 18). A longitudinal crack was noticed on the upstream face near the right abutment about 6 inches below the crest. Should this crack develop to the extent that the crest is lost in that area, the hydraulic performance of the dam will be greatly altered.

i. Spalling of concrete to a depth of from 3 to 6 inches over most of the downstream face of the main spillway section (Fig. 3, Appendix D) and along some sections of the spillway crest (Fig. 24, Appendix D). Some of this spalling may be of an unreported gunite resurfacing.

ii. Longitudinal cracking over much of the concrete gravity structure at all levels (Figs. 3, 5, 18, Appendix D). Because of the flow of water over the dam, we could not determine whether these were structural cracks or construction joints.

FIGURE 3      DOWNSTREAM FACE NEAR RIGHT ABUTMENT

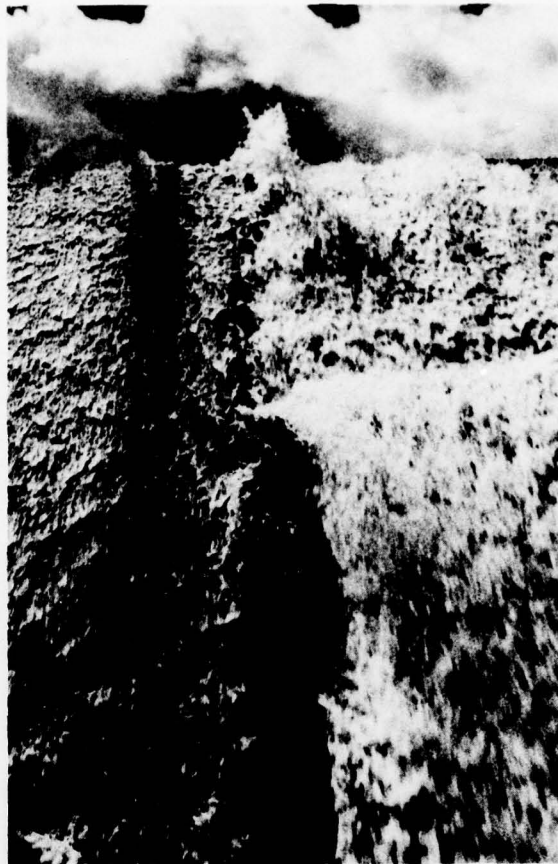
FIGURE 4      WATER SPLASH IN OPEN JOINT

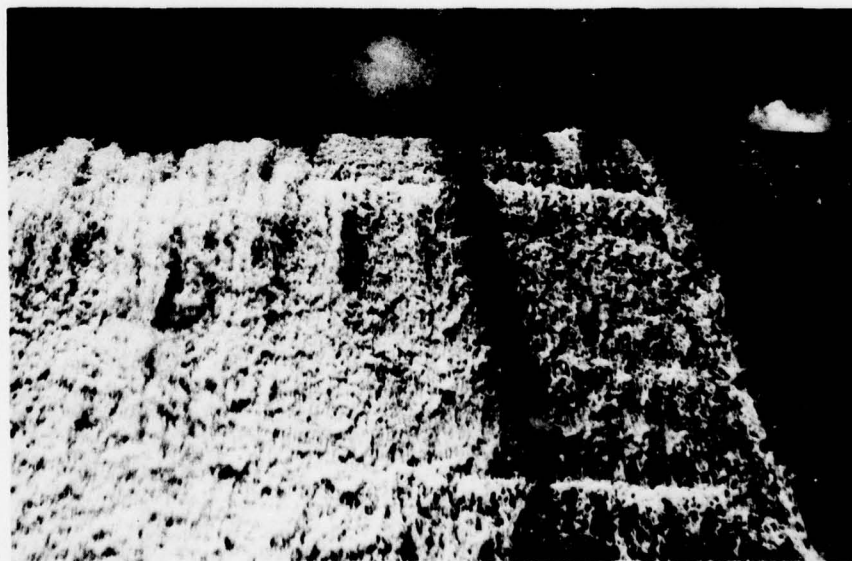
FIGURE 5      WATER SPLASH OVER CRACKS AND SPALLS ON UPSTREAM FACE  
AND ALONG CREST

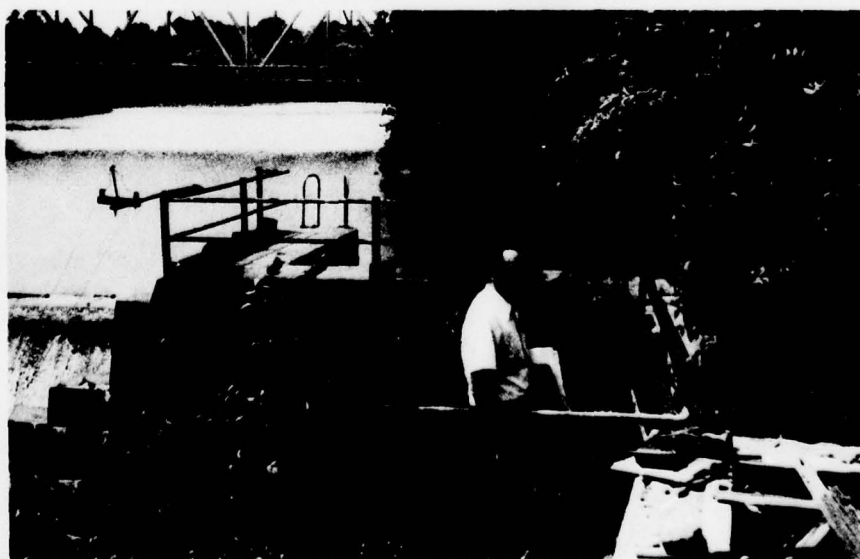
iii. The gate control platform is in good condition. The access to it is via a wooden stairway and bridge. The basic support for this access structure is a steel frame which seems to be in satisfactory condition, but the wooden boards are rotten and both the stairway and the bridge are

overgrown with vegetation. (Fig. 11, Appendix D.) The iron handrail and stairs leading from the control gate platform to the side-channel spillway crest are rusted out and could not be used safely. On the day of the inspection water was not flowing over the side-channel spillway. There was still water behind the spillway which submerged the vertical lift gate so that only the trash rack was visible. The gate controls are rusted and inoperative (Fig. 12, Appendix D). They are apparently driven by an electric motor and belt system but there is no electrical supply at or near the gate platform, so the gate cannot be operated. Even if there were an electrical supply at hand it is questionable whether the gate controls would work.

FIGURE 11      LEFT ABUTMENT AREA AND ACCESS STRUCTURES

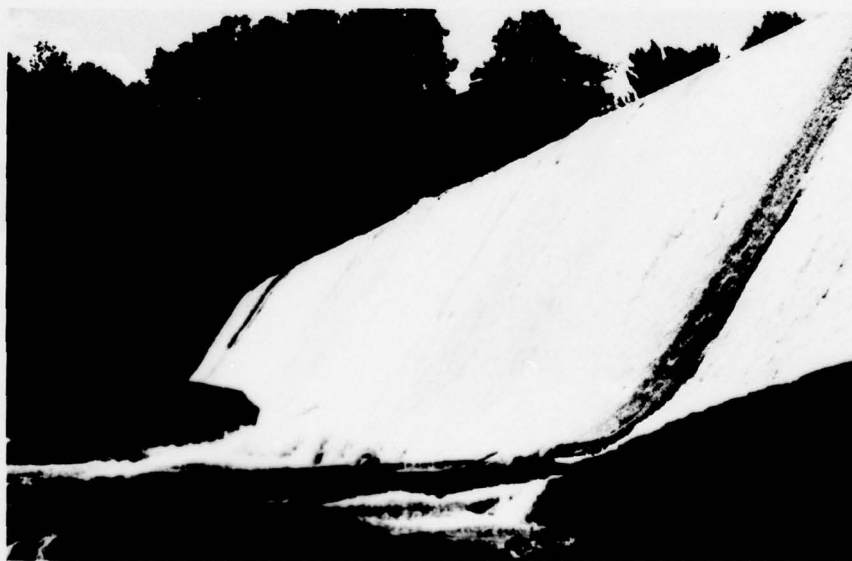
FIGURE 13 DOWNSTREAM FACE SHOWING POSSIBLE MONOLITH OFFSET

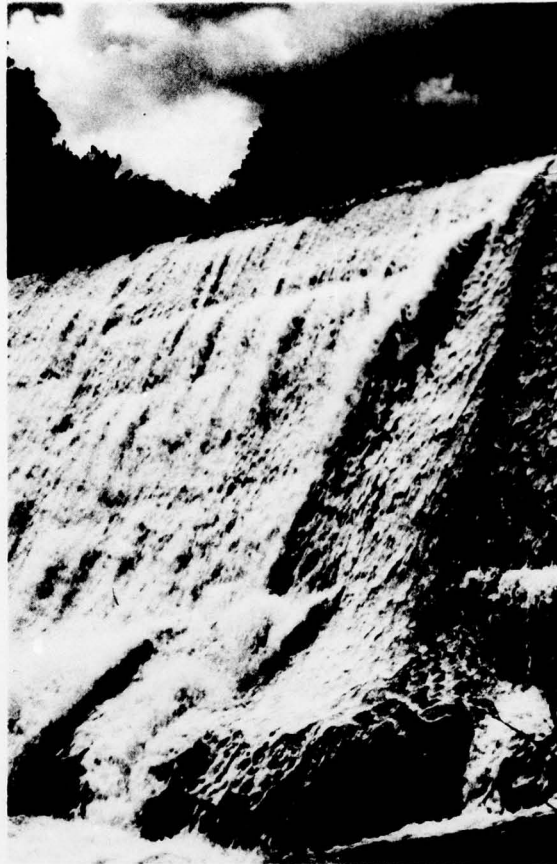
FIGURE 18      EXIT PORTALS OF TWO SLUICE PIPES ON DOWNSTREAM FACE

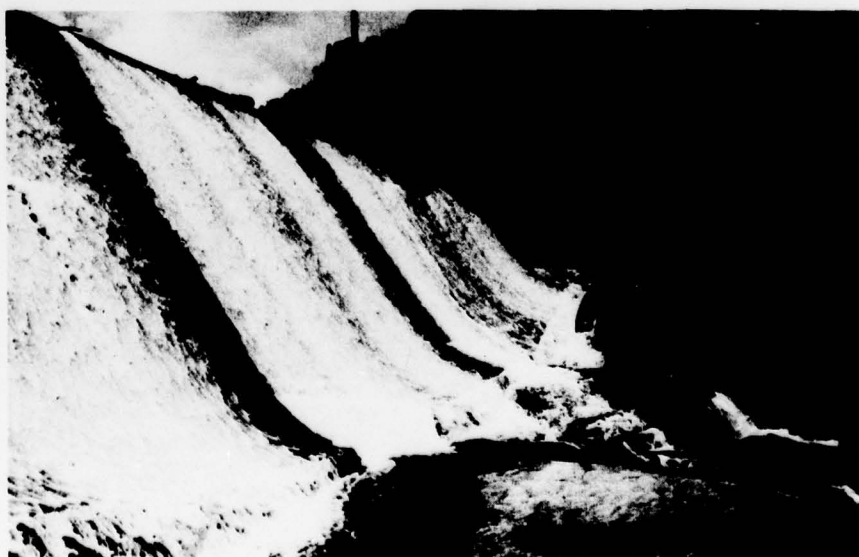
FIGURE 23      DOWNSTREAM FACE SHOWING POSSIBLE MONOLITH OFFSETS AND  
LEAKAGE BENEATH AND THROUGH SIDE CHANNEL SPILLWAY
